RE: Visual Indoor Air Quality Assessment Report
Big Lots
18325 S Dixie Hwy
Miami, Florida 33157
GHP Project Number: **240897.00**

VISUAL INDOOR AIR QUALITY ASSESSMENT REPORT

Visual Indoor Air Quality Assessment Report

GHP Project No. 240897.00

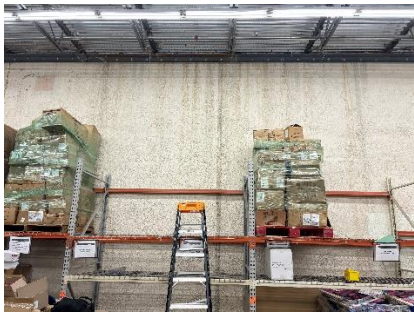
Visible Water stains and suspect visible growth in the Warehouse Wall

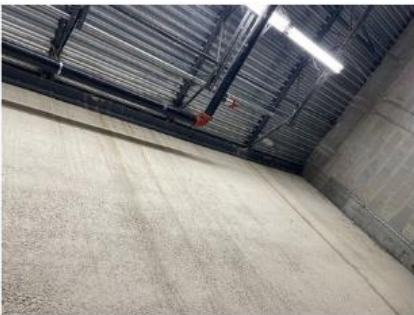
Visible Water Stains and suspect visible growth on the Warehouse Wall

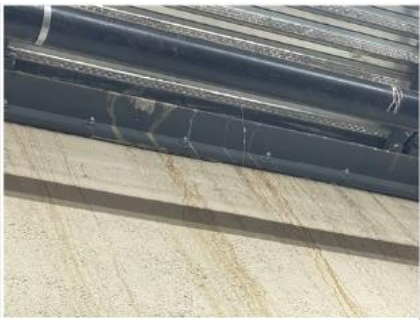
Visible Water stains and suspect visible growth in the Warehouse Area

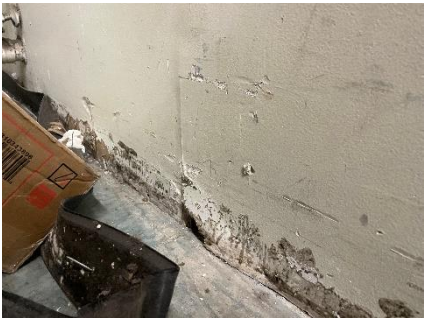
Visible Water stains and suspect visible growth on drywall at floor level

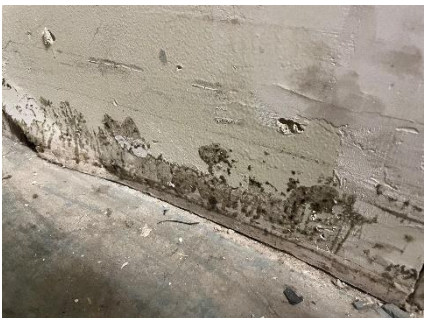
Visible Water stains and suspect visible growth on drywall at floor level

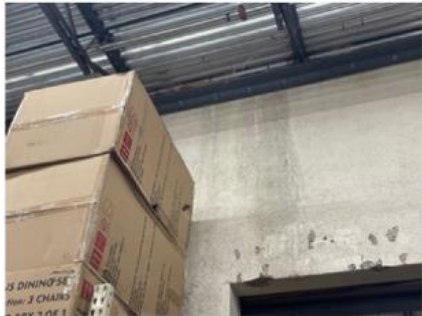
Visible Water Stains and suspect visible growth in the Warehouse Area

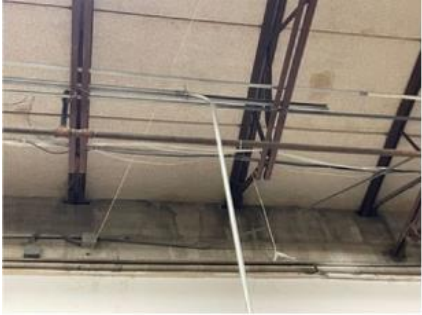
Visible Water Marks

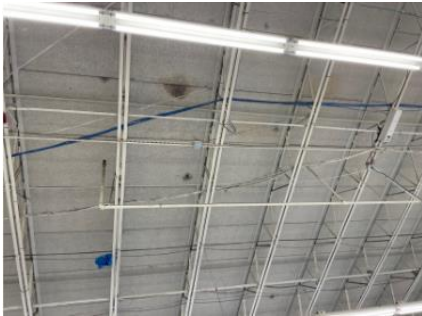
The observed water staining indicates building envelope issues, which are suspected to be associated with the roof based on the location of water staining. Suspect visible growth was observed in many areas where water staining was present, which may indicate that moisture issues are still present or suspect visible growth was not addressed after moisture issues were resolved. GHP recommends assessing the building envelope for moisture intrusion issues. GHP also recommends assessing the HVAC system for moisture intrusion issues and/or condensation issues. Any observed water staining and suspect visible growth should be addressed. Ceiling tiles with water staining and/or suspect visible growth should be removed and replaced. Note that if underlying envelope and HVAC system issues are not resolved, the potential exists for the recurrence of water staining and suspect visible growth after they have initially been addressed.

Visible water staining and suspect growth on underside of roof deck
